Braden Roofing News Vol. 2 The Home Owner's Guide to Hail

COMPOSITION SHINGLE HAIL DAMAGE

WOOD SHAKE HAIL DAMAGE

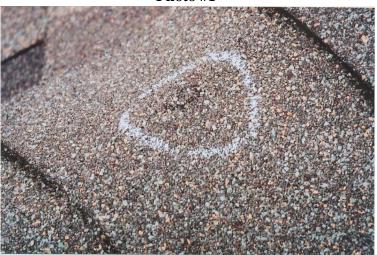
The first place to look for hail damage on any roof is on the vents and ridges. Ridges are especially prone to damage (see photo #1). Photo #1

Hail often damages ridge shingles.

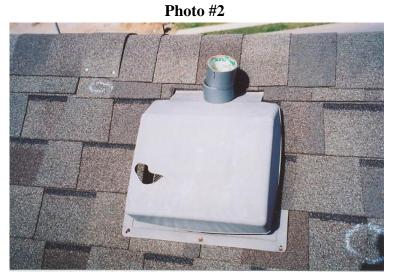
Frequently, vents will be damaged by hail hits. Dents in metal vents are a good hint that the entire roof needs to be closely examined for hail hits. Plastic vents will frequently shatter, leaving big, gaping holes (see photo #2). Not only do these holes indicate hail damage, but they also indicate the need for a quick emergency repair.

Hail hits can leave large leak-prone holes in vents. Duct tape can provide a quick emergency repair.

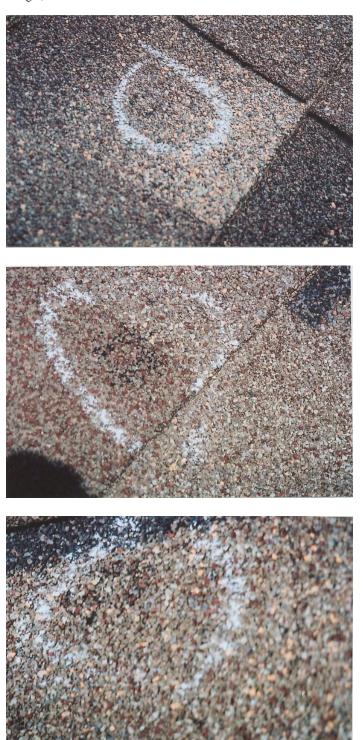
Photo #4

Hail damage on a composition shingle typically manifests itself as bruise or small dent in the shingle. Usually, the granulation is displaced, exposing the asphalt (see photos #3, #4, and #5). When you touch the hail hit, you can usually feel a soft spot in the shingle. The reason you can feel this soft spot is that the fiberglass matting of the shingle has been broken. When the fiberglass matting of the shingle has broken, the asphalt has no backing, and tends to simply melt away in the summertime. This is why hail damage is sometimes not apparent on a shingle roof until after the roof has been cooked in the summer sun. It is always a good idea for the adjustor or roofer to feel for these soft spots in the shingle, EVEN IF YOU CANNOT SEE ANY APPARENT HAIL DAMAGE.

Photo #5 Hail hits on composition shingle.

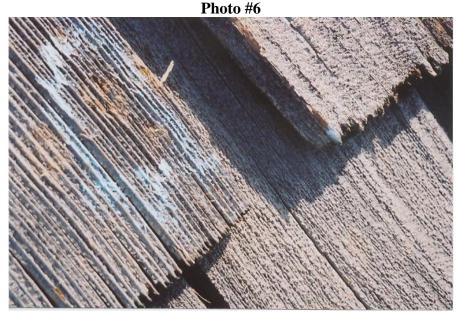
The reason for the difference in hit counts has to do with the "repair ability" of a roof. Another consideration in the repair ability of a roof is the shingle thickness, course length, and whether the roof was installed with nails or with staples. A thicker roof on a tighter course and installed with staples will be substantially more difficult to repair than a standard application. Any one of those three considerations (and especially the staples) may cause a roof to be "un-repairable". An un-repairable roof should be totaled out, regardless of Haag standards. Many insurance companies will balk at this caveat, but it is true nonetheless. Please note that a crack or break in a shingle may NOT BE APPARENT JUST BY LOOKING AT THE SHINGLE!!! Please look at photo #6. The hail crack is not apparent to simple observation. This is frequently the case with edgegrain and slashgrain shingles (and not so much so with flatgrain). Most shake roofs will have a mixture of edgegrain, slashgrain, and flatgrain shingles. To determine if an edgegrain or slashgrain shingle has hail damage, you MUST PHYSICALLY FEEL THE SHINGLE.

Edgegrain wood can hide cracks. Do you see the hail crack in this shingle?

Rare, indeed, is the insurance adjustor who takes time to feel every darn shingle in a Haag square. Many don't even get on the rooftop. At Braden Roofing, we feel that visual inspection, even from the rooftop, is not adequate to accurately gauge hail damage. Observe photo #7. This is the same shingle as in photo #6, with the crack physically separated out for easy observation.

This is the same shingle as in Photo #6 with the crack now easily seen. This kind of crack is often missed by adjusters and roofers alike.

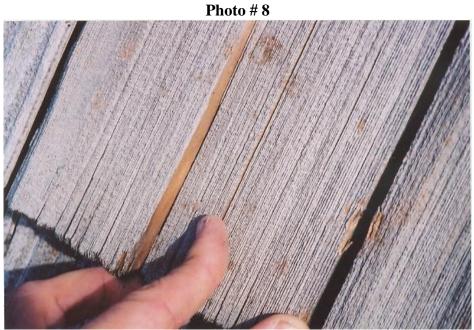
Photo #8 shows a shingle with multiple hits causing multiple cracks. For purposes of Haag diagnosis, this would count as multiple hits, even though only one shingle is actually affected.

Multiple hits and cracks on the same shingle count as multiple hits per HAAG

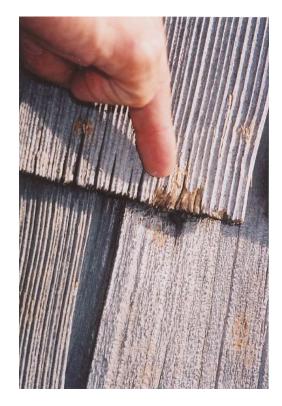
Photo #9 shows what is commonly referred to as a "butt rot hit" (no, I am not making this up!). This is the most controversial of hail hits.

Photo #9 Butt rot hits still co unt if fresh wood is exposed. First of all, the lowest edge (butt end) of a shake shingle, as it ages, begins to deteriorate and soften faster than the rest of the shingle. As such, a hail hit on this part of the shingle will tend to break the wood more easily. In the past, many insurance companies have rejected this hit in their Haag count. However, most insurance companies will now count a butt rot hit IF fresh (orange) wood is exposed. Photo #9 shows a shingle that we feel should qualify under Haag.

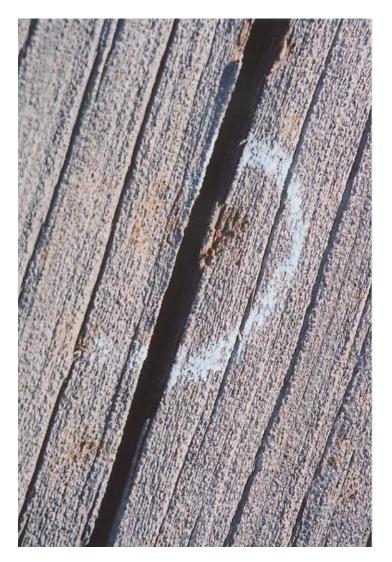
Sometimes, a customer may ask us if hail damage really shortens the life of a roof. Generally speaking, the answer is yes, as split shingles expose the felt underlayment of a shake roof to more weathering. Sometimes a legitimate hail hit as defined by Haag will not truly shorten the life of a roof, as in photo #10. In this picture, we see that a hail hit has torn the edge of the shingle, exposing fresh wood, and thus, qualifying for Haag. Will this hit (all other things being equal) shorten the life of this roof? Probably, but not by itself though. Nonetheless, we should still count this as a hit per Haag. Most Haag qualifying hail hits, however, do indeed shorten the life of a roof.

Photo #10 This hit qualifies for HAAG because fresh wood is exposed.

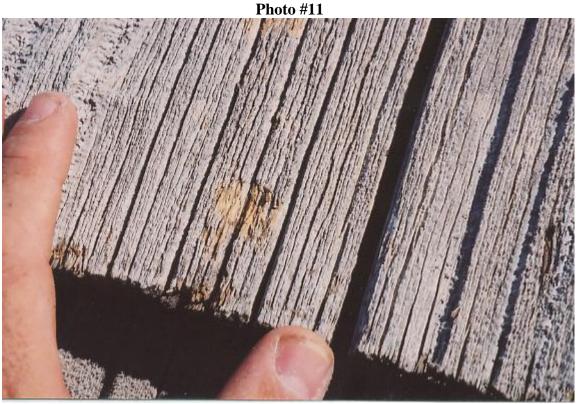
Age related cracks do not qualify as hail damage.

Please note that not all cracks in shake shingles are caused by hail. Shake shingles will frequently crack due to age and weathering. Such damage, while certainly a problem for a wood shake roof, does NOT qualify as hail damage under Haag guidelines. Photo #11 shows a shake shingle which has been clobbered by hail, and also has concurrent cracks. However, it is obvious that the cracks were due to weathering, not hail. This is not considered hail related damage.
